# Assessment of Dam Safety

## Coal Combustion Surface Impoundments (Task 3)

Dayton Power &  
Light Company

JM Stuart Station

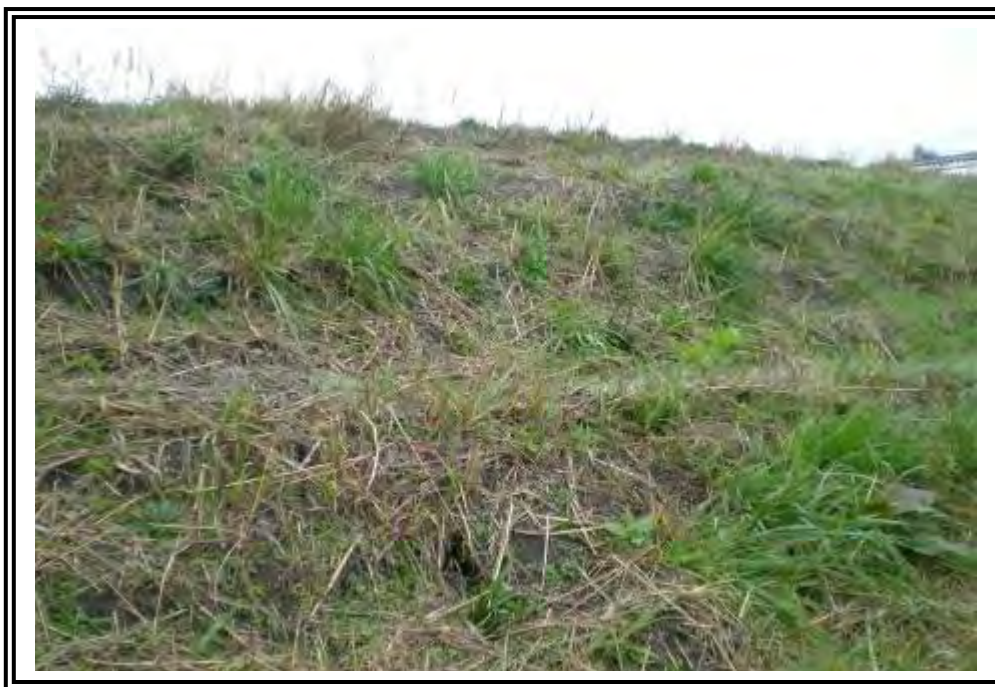
5

A close up of some rutting and loss of grass cover from mowing activities.

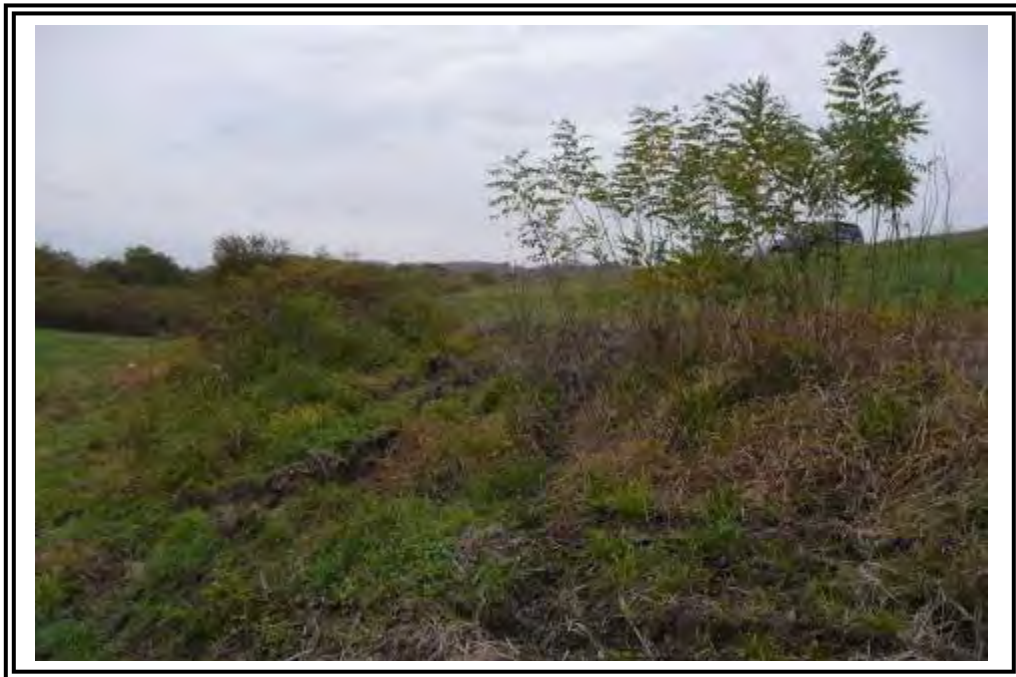
10

In general, the south dike (Photo 6) and the north dike (Photos 20 and 21) appeared to be maintained and mowed. However, seepage initiated slope softening and subsequent mowing induced rutting and slope deformation was observed on the downstream slopes of the dikes in at least four locations. One such area measured approximately 326 feet long approximately 52 feet from the toe with 6 to 12 inches of standing water (Photos 15 and 16). These areas often had heavier vegetation, scrub brush, and small trees established where routine tractor mounted mowing had not occurred for a fairly long period of time as a consequence of the softened slope conditions (Photos 11 and 12). In most cases however, these areas were generally covered with heavier grass and other weedy vegetation (Photos 10, 19 and 22)

Seep softened and deformed area with denser vegetation on the downstream slope at the southwest end of the pond.

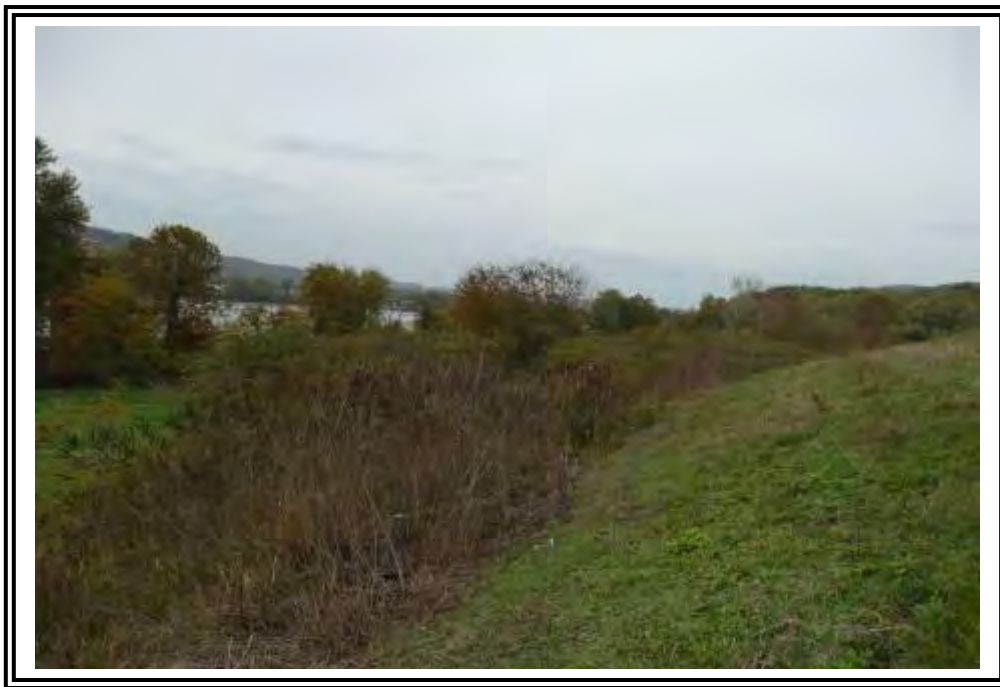
11

Heavier vegetation noted in area of seep on southwest end of pond.

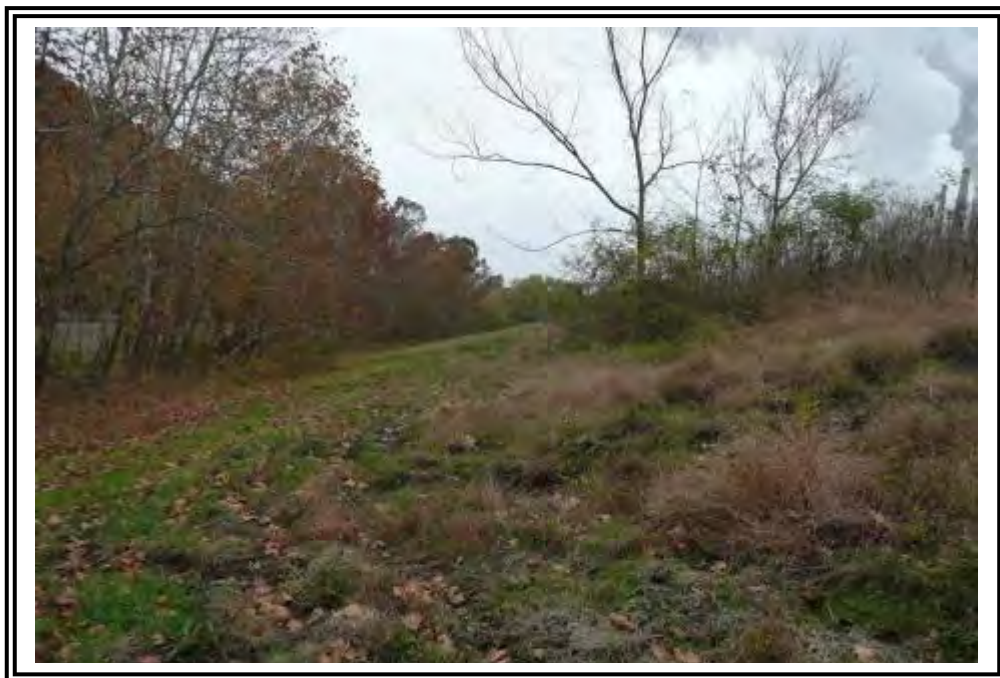
12

Another view of heavier vegetation and slope deformation in seep area at west end of pond.

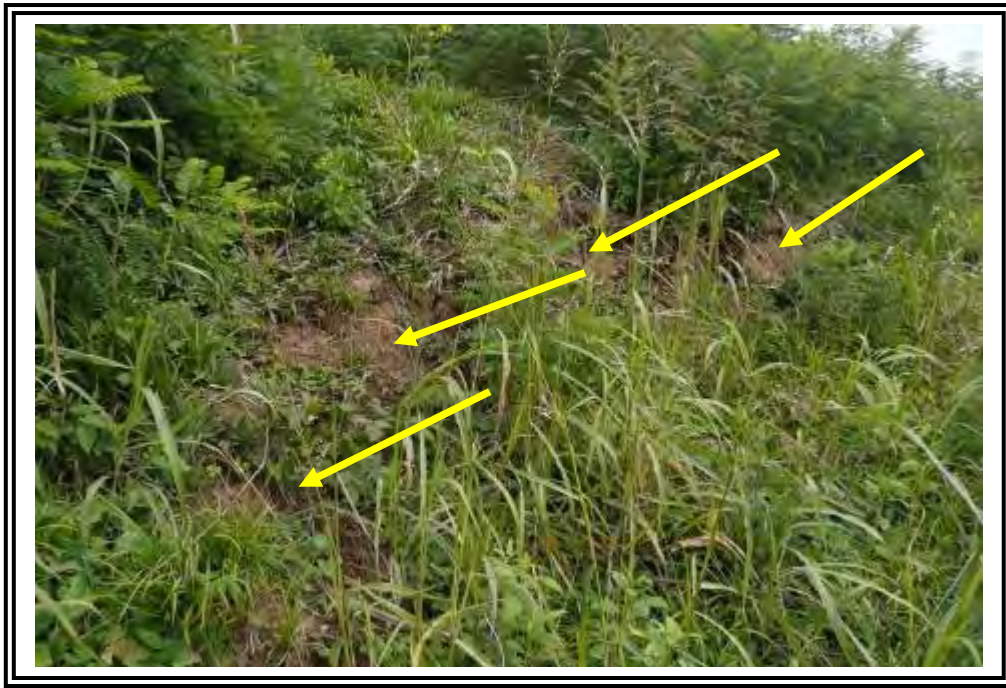
13

In addition to the seeps and resulting softened slope areas, scarp areas were observed on the south side of the pond and western extremity of the pond. A scarp on the south dike (Photo 13) occurred along a heavily vegetated, over-steepened portion of the dike adjacent to a haul road drainage ditch. It measured roughly 52 feet in length along the dike centerline. The scarp encountered on the west end of the pond measured approximately 30 feet in length and appeared to occur in a location of softer soil (Photo 14). Standing water was observed in this scarp and the soft soil in the area of the scarp it is likely the result of seepage at this location.

Partially vegetated scarp in heavily vegetated, steeper slope on south side of the pond.  
Approximately 52 feet long. (See arrows)

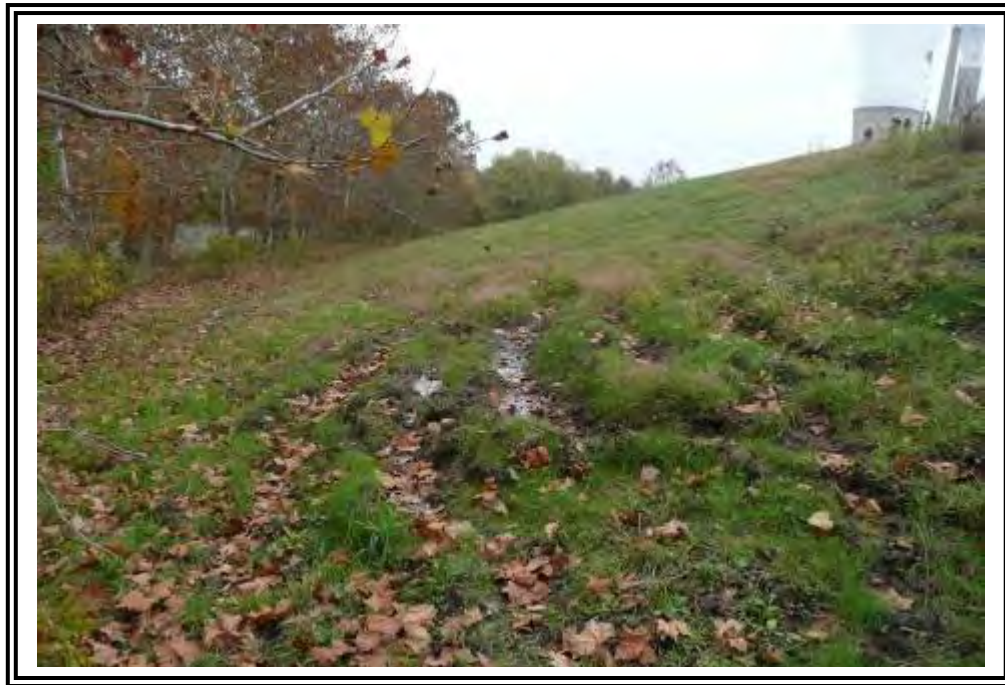
19

Looking east along the downstream slope of the northern dike.  
Notice the taller grass and rutting with standing seep water.

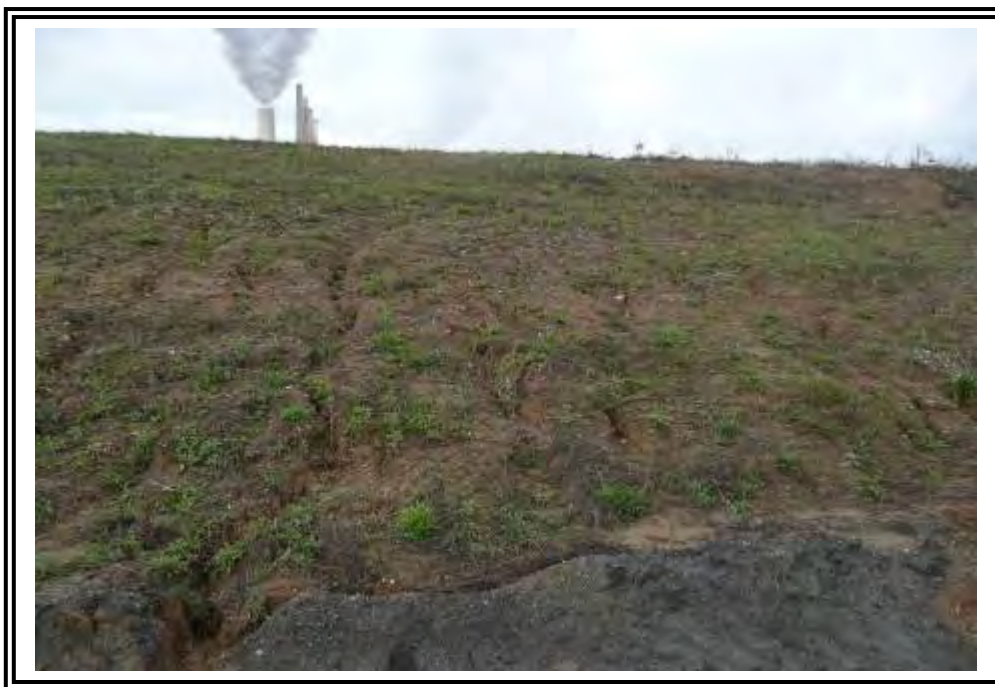
47

A close up of erosion rills and loss of grass cover on the downstream slope of the east dike.

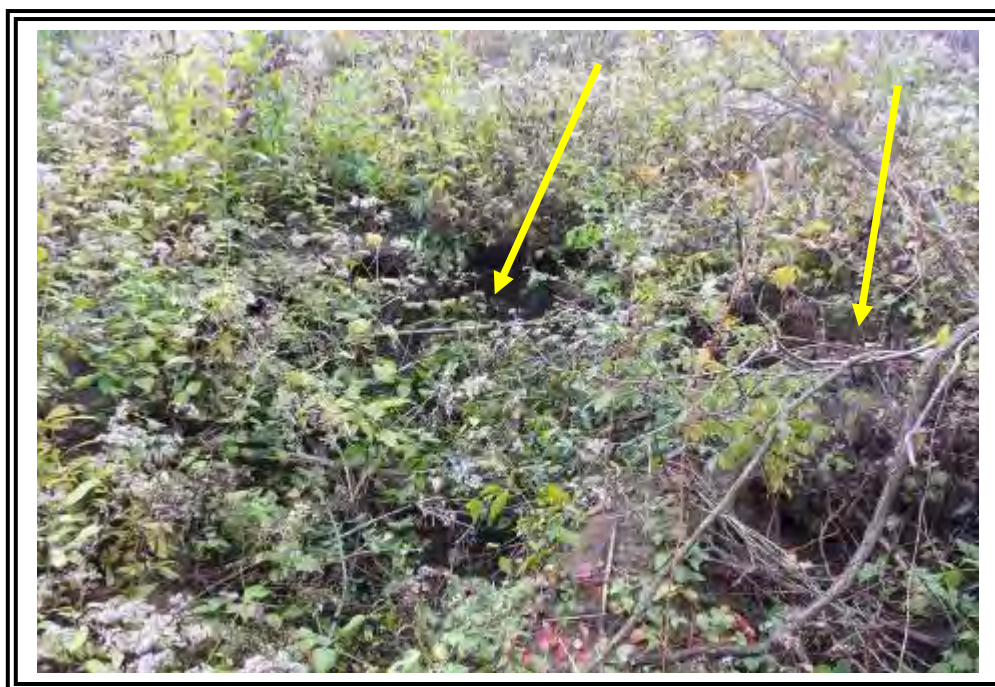
65

Deep, heavily vegetated erosion gullies on downstream east dike slope of Pond 6.  
These were 3.5 to 4 feet deep located near the north end of the dike.

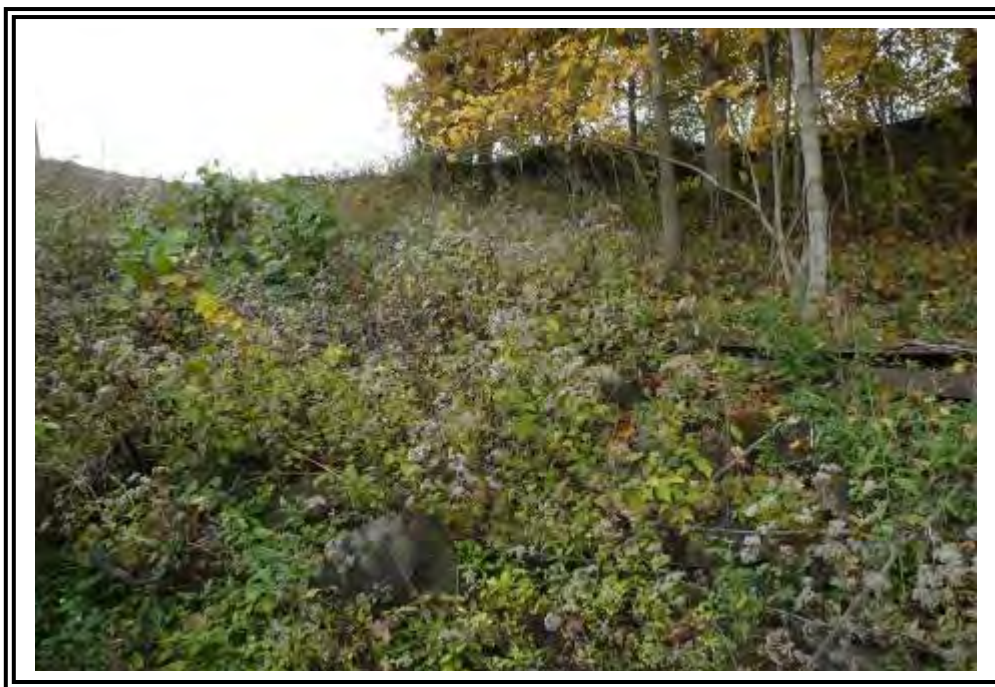
67

Looking up slope at the start of the eastern dike at Pond 6.  
Vegetation obscures rock groin in this area.

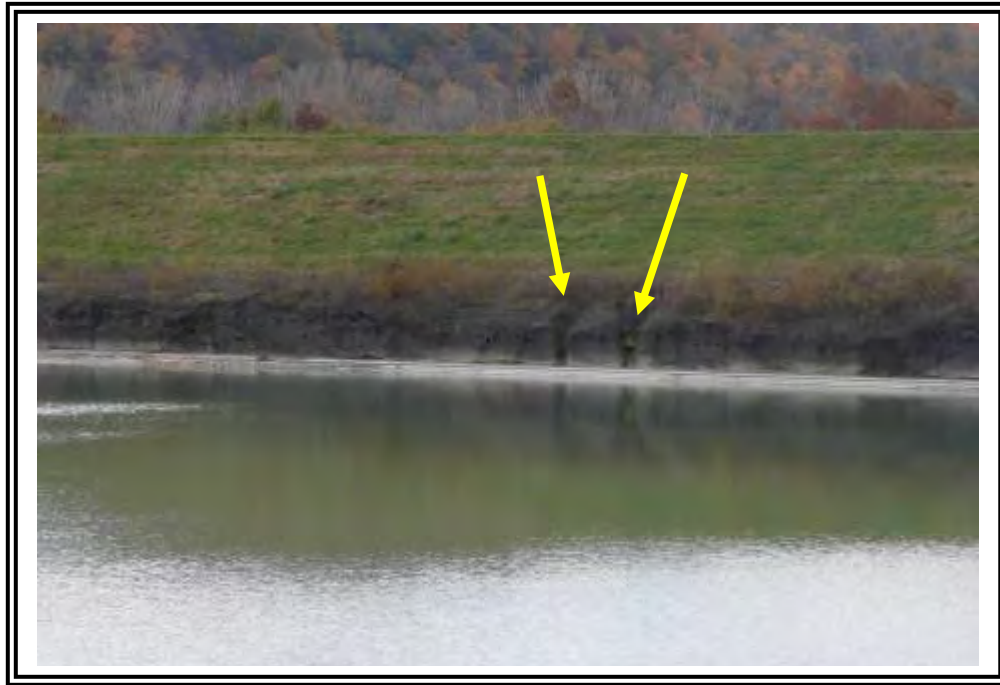
95

Looking west at steep upstream slope and erosion rills (arrows) on western dike of Pond 7.

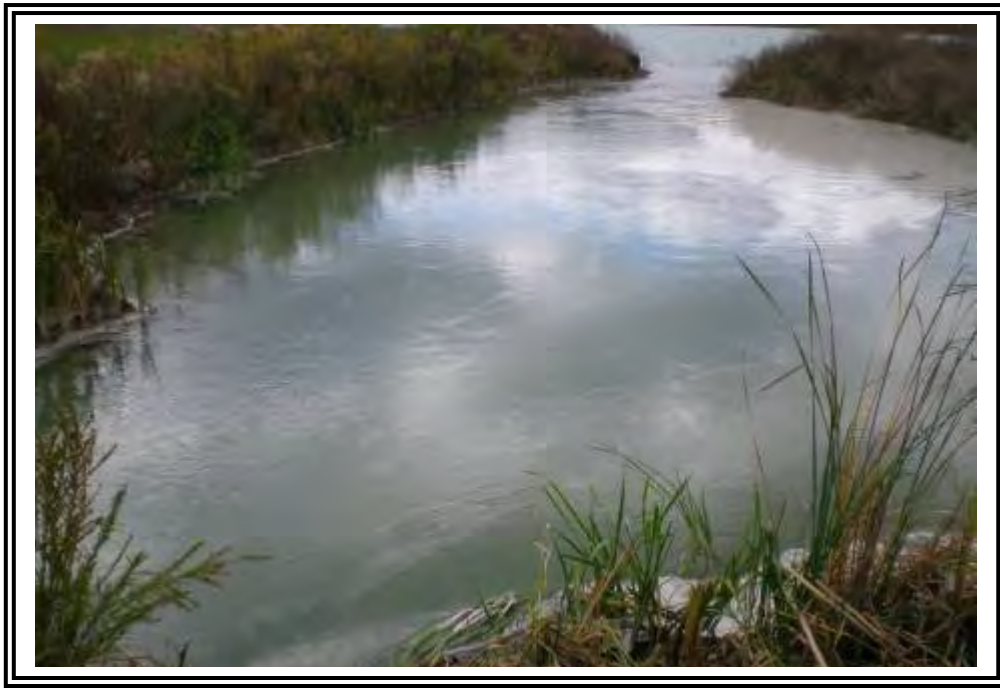
The Pond 7 outlet structure is a drop inlet connected to a culvert conveying water through the north dike into Pond 6. It is located in a small channel excavated through the ash fill separating Ponds 7 and 7A (Photo 101 ). At the time of the site assessment, it was submerged and could not readily be observed. It did not appear to be obstructed and was functioning as required. A trash rack or similar device was not readily visible. (Photo 102)

Channel to outlet structure excavated through ash fill in northwest corner of Pond 7.
